Content, Impact and Cause Analysis of Input Data Errors in Seismic Safety Evaluation Reports for Hamaoka Nuclear Power Station Reactors No. 3, 4 and 5 (Outline)

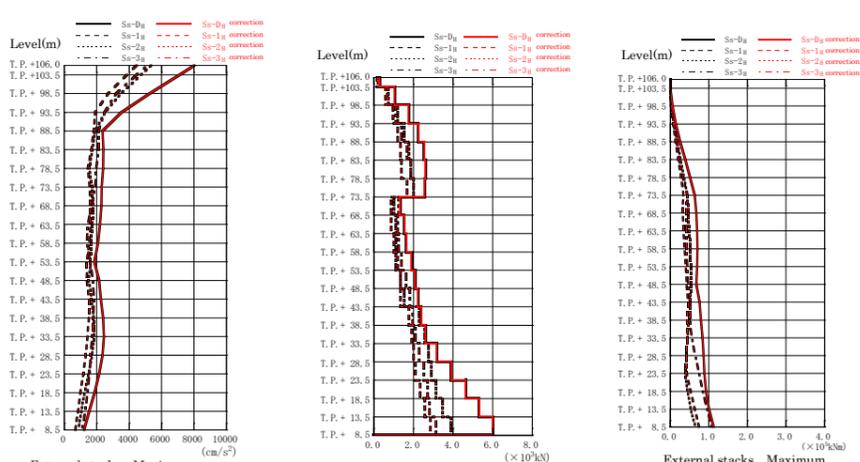
<p style="text-align: center;">Comparison of response before and after correction of input data (Direction: 90° horizontal)</p>	<p>Contractor (Company A):</p> <ul style="list-style-type: none"> • At the time of the analysis (March 2007), a method of checking that data had been correctly input had not yet been established in in-house rules. • Because of this, despite the fact that the staff members responsible for the analysis checked the screen after inputting each figure based on materials providing bases for input, in the one case indicated, the figure was not checked on the input screen. It is believed that the figure was overlooked because it was difficult to discriminate between figures on the screen. • In addition, because no staff members other than those responsible for conducting the analysis checked that the data had been correctly input, the error was not discovered.
