1. Overview of incident

During the process of achieving cold shutdown following the shutdown of Hamaoka Nuclear Power Station Reactor No. 5 on May 14, 2011, the readings of conductivity meters monitoring the purity of the water in the main condensers began to rise, and the conductivity of the water in the reactor also began to increase.

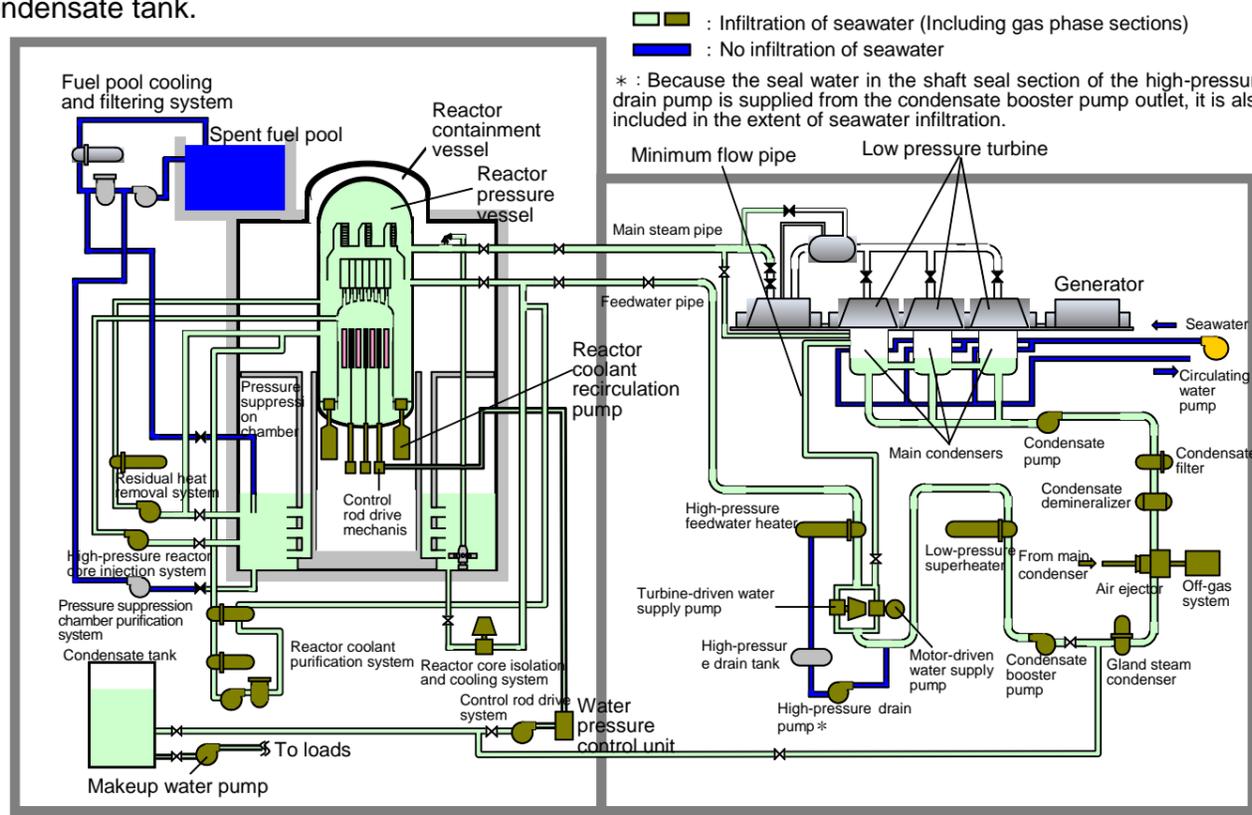
The extent of the infiltration of seawater into the reactor facilities was estimated from the operating status of the reactor at the time of the incident and changes in electrical conductivity. Salt removal procedures have been conducted in order to limit the effect of salt on the equipment. The diagram below shows the extent of seawater infiltration.

The volume of seawater that infiltrated the facility in this incident has been calculated as approximately 400 m³ in total, based on changes in the water level of the main condensers and the condensate tank.

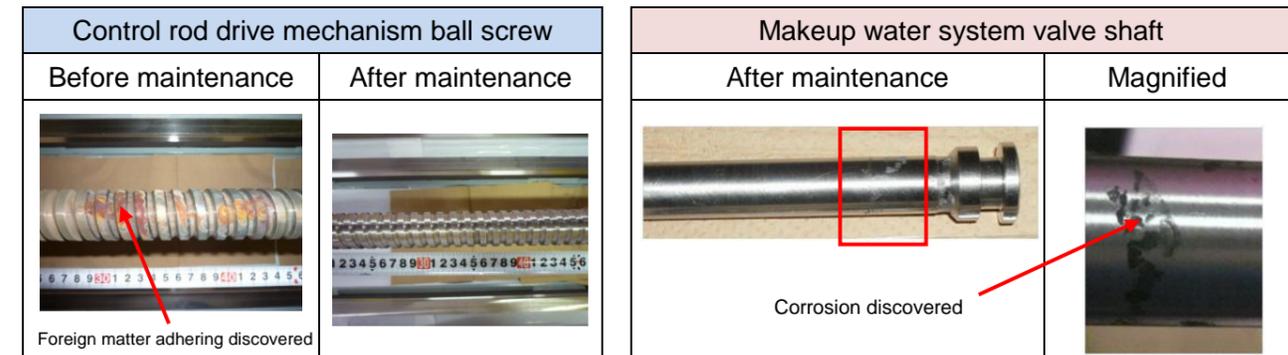
(Examples of results of examination of actual equipment)

- Overall, more adhesion of foreign matter and more corrosion was discovered than in previous inspections, but this was able to be removed by maintenance procedures.
- In the case of the control rod drive mechanism, corrosion was discovered in parts including nitrated parts.
- In the case of the control rod drive water system, corrosion was discovered in parts including some of the valves in the makeup water system.
- In the case of the condensate tank, holes were discovered in and around the welded section of the lining.

With regard to the holes in the condensate tank, we will elucidate the causes and formulate measures to prevent a recurrence. At present, we are engaged in repairing the affected areas. Following the repair of the condensate tank, we will open the reactor and verify the soundness of the internal equipment.

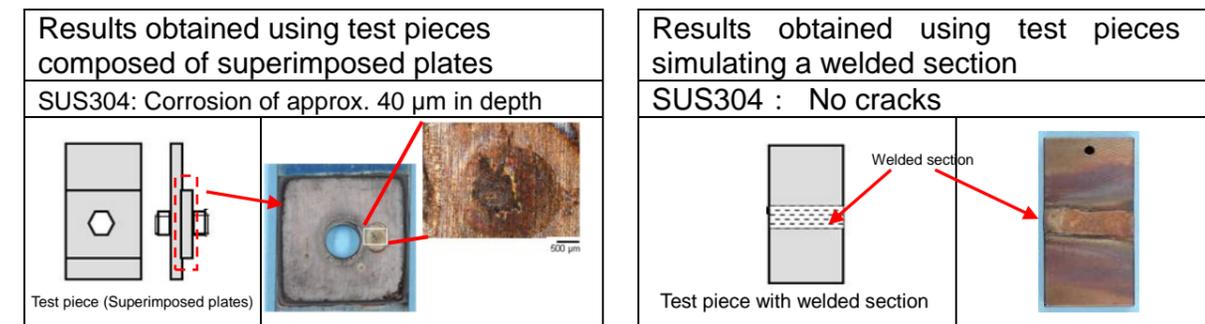
(Examples of results of materials tests)

- Corrosion tests using test pieces consisting of superimposed plates showed that corrosion formed on stainless steel plates.
- Stress corrosion cracking tests using test pieces that simulate the welded sections indicated that no cracking occurred in the stainless steel plates.
- Corrosion tests conducted using test pieces that simulate the structure of the pump shaft and impeller section showed that corrosion formed in the gap between the stainless steel shaft, the impeller, and the key.
