Causes of Corrosion Holes in Condensate Storage Tank Lining and Measures to Prevent Recurrence

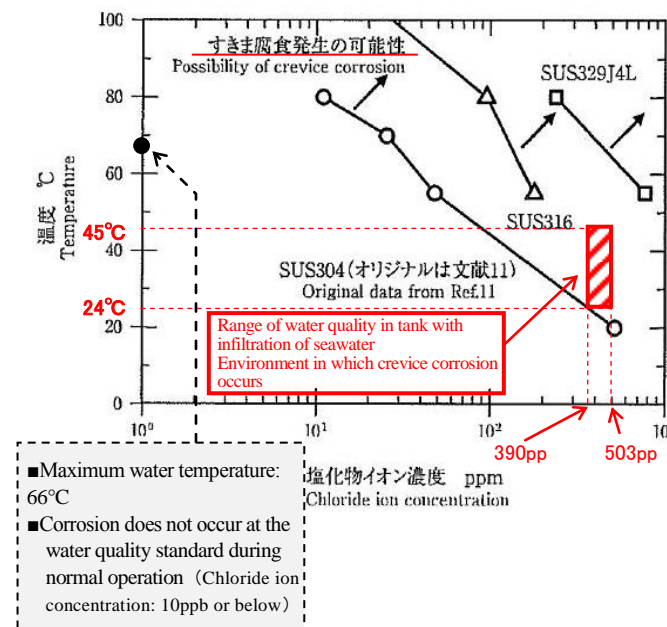
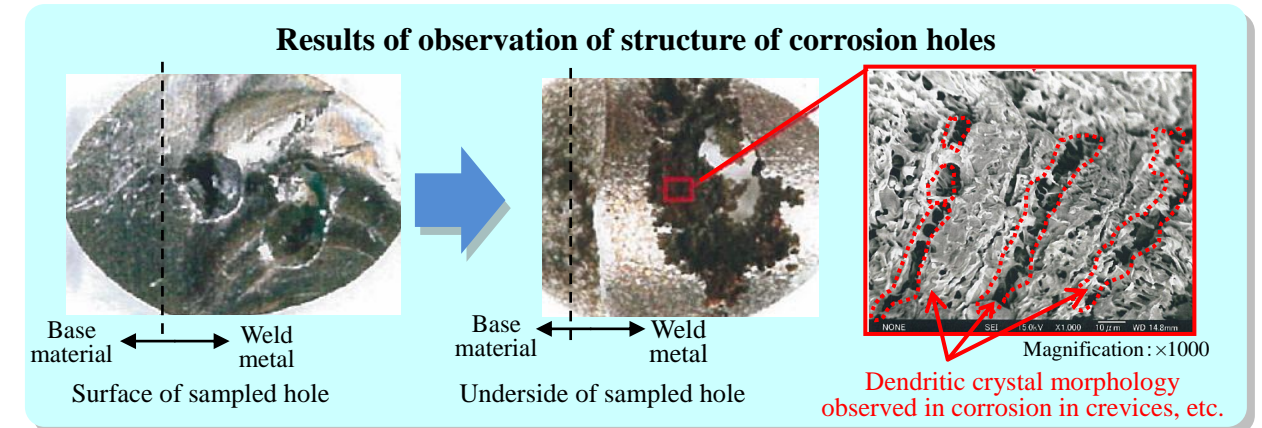
A review of relevant studies^{*1} indicated that the water quality environment following the infiltration of seawater (Chloride ion concentration: 390-503 ppm^{*2}; Water temperature: 24-45°C) and the build-up of crud would create an environment promoting crevice corrosion.

A sample of a corrosion hole was taken and its structure was observed. The results of these observations showed a dendritic crystal morphology characteristic of crevice corrosion.

It is believed that the infiltration of seawater into the condensate storage tank while the tank had a build-up of crud resulted in the formation of an environment that promoted corrosion in the crevices between the crud and the lining. Corrosion proceeded in these crevices until holes penetrated the lining.
