# Inspection Results for Low-Pressure Turbine Moving Vane Mounting Assemblies (on the moving vane side) in Hamaoka Unit 3 and Unit 4 with Causes and Countermeasures

## 1. Overview of incident

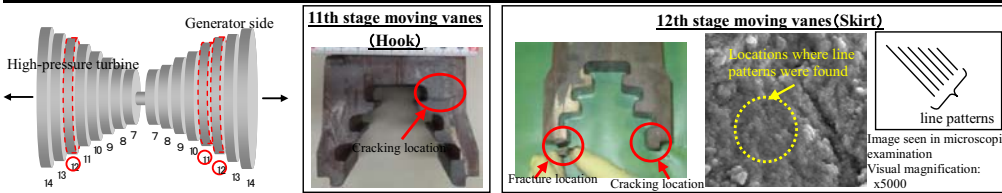
■ The low-pressure turbine moving vane mounting assemblies (on the moving vane side) in Unit 4 were subjected to ultrasonic testing and magnetic particle testing, and cracking was found in 19 of the 144 moving vanes in the 11th stage on the generator side of low-pressure turbine C. Fractures were also found in 10 of the 900 moving vanes in the 12th stages of low-pressure turbines A to C, and cracking in 107 of those moving vanes. (See Table 1 and Figure 1.)

Figure 1. Inspection results for moving vane mounting assemblies (on the moving vane side)

■ Areas where cracking and fractures were found were subjected to surface examination by microscope. The results confirmed the presence in fracture surfaces of fine line patterns (striations) that are characteristic of high-cycle fatigue. In addition, the cracking that had occurred in the 11th stage of low-pressure turbine C had rust and other such corrosion extending to the very ends of the cracks. No fresh metal fracture surfaces were found, suggesting that the cracks had occurred in the past and had not advanced into surrounding areas since that time. (See Figure 1.)

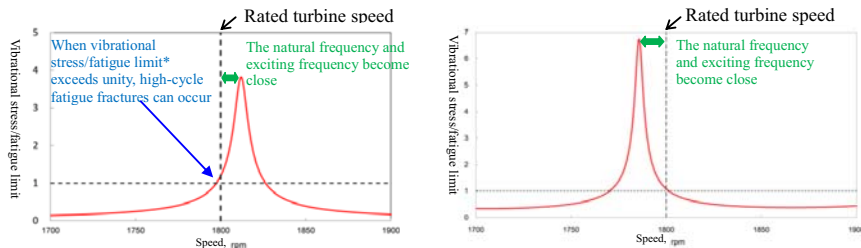
■ Characteristics of high-cycle fatigue were found, so an evaluation was made of the occurrence of high-cycle fatigue fractures. The evaluation results confirmed that the natural frequency (the characteristic frequency of an oscillating body that is allowed to oscillate freely) of the moving vane was close to the frequency that was 9 or 11 times the rotating frequency of the turbine (30 rotations per second, or 30 Hz). This resulted in the generation of resonance and an increase in vibrational stress, which is thought to have caused the high-cycle fatigue fractures. (See Figures 2 and 3.)

Figure 2. Natural frequency and exciting frequency of 11th stage moving vanes (hooks)

Figure 3. Natural frequency and exciting frequency of 12th stage moving vanes (Skirt)

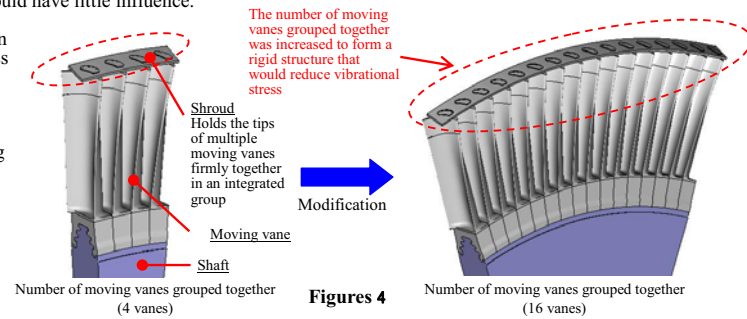
Figures 4

■ The 11th stage moving vanes had been subject to countermeasures in the past to reduce vibrational stress due to resonance by changing the number of moving vanes grouped together from four vanes to 16 vanes. The cracking in these parts had not advanced into surrounding areas after its occurrence, which suggested that resonance had occurred, and the high-cycle fatigue fracture had occurred before the number of moving vanes grouped together had been changed. (See Figure 4.)

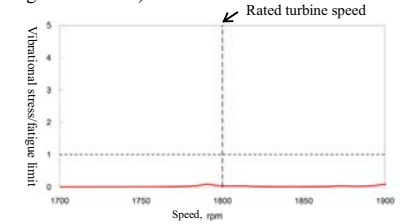
Figures 6 Natural frequency and exciting frequency of 11th stage moving vanes placed in groups of sixteen vanes

The cracking that occurred in moving vane mounting assemblies (on the moving vane side) on the 11th stage of low-pressure turbine C occurred before the modification of the number of moving vanes grouped together. Stress analysis was conducted of the current state of moving vanes in modified groupings (from four vanes to 16 vanes). The results confirmed that the stress occurring in the moving vane hooks was sufficiently lower than the vibrational stress capable of causing high-cycle fatigue, and that the vanes could be restored to service by altering the design. The moving vanes in which cracking was found will be replaced with new vanes. (See Figures 5 and 6.)

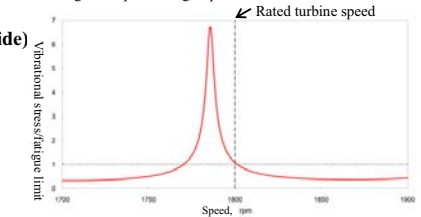
Figures 8 Natural frequency and exciting frequency of 12th stage moving vanes placed in groups of six vanes

In the 12th stage, countermeasures for the moving vane mounting assemblies (on the shaft side) involved the installation of pressure plates. While this is done, therefore, the turbine will be operated with all of those moving vanes removed. When the turbine is to be operated with the pressure plates removed, new replacement moving vanes will be installed. When replacement takes place, the moving vane groupings will be modified (from six vanes to 11 or 13 vanes) in a design intended to reduce vibrational stress. In addition, the natural frequency of the moving vanes following replacement will be confirmed and the influence of the increased vibrational stress due to resonance will be confirmed. (See Figures 7 to 9.)

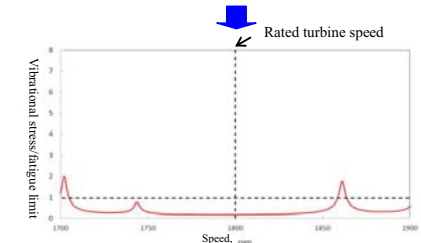
Figures 9 Natural frequency and exciting frequency of 12th stage moving vanes placed in groups of eleven vanes
