## Overview of Report on Initiatives to Increase Seismic Safety at Hamaoka Nuclear Power Station Reactor No. 2

Following the directions of the then-Nuclear and Industrial Safety Agency (NISA) of the Ministry of Economy, Trade and Industry (METI), Chubu Electric Power has reported on its initiatives to increase seismic safety at Hamaoka Nuclear Power Station Reactor No. 2, which is currently being decommissioned. An outline of the report is provided below.

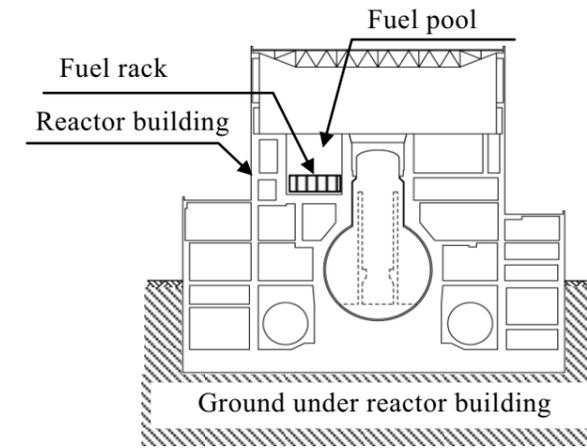
Fig. 1: Cross-section diagram of Hamaoka Reactor No. 2 reactor building

- The reactor building, ground under the reactor building and fuel racks (Fig. 1) at Hamaoka Nuclear Power Station Reactor No. 2 are essential for assuring the spent fuel cooling function, sub-criticality function and containment function (including shielding), and these functions are in turn essential for ensuring the safety of spent fuel<sup>\*1</sup> at the reactor. We evaluated the seismic safety, etc. of the reactor at standard seismic motion Ss (800 Gal in horizontal direction) and reported the results to NISA in March 2012.

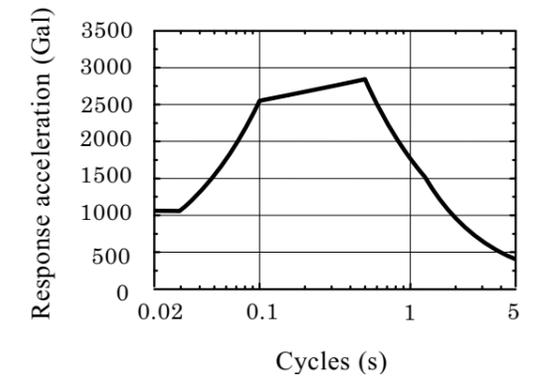
Fig. 2: Target ground motion response spectrum

- Following an action plan adopted in response to a directive<sup>\*2</sup> from the then-NISA of METI, Chubu Electric Power has been taking initiatives to enhance seismic safety at Reactor No. 2. This includes checking the seismic durability margin of that facility using the target ground motion (about 1,000 Gal in the horizontal direction) (Fig. 2) that was established to increase the seismic safety durability margins of Reactors No. 3-5. We are also considering margins for ensuring fuel pool water and spent fuel sub-criticality to ensure the safety of that spent fuel. In light of our findings, we will report on measures necessary to enhance the safety margins.

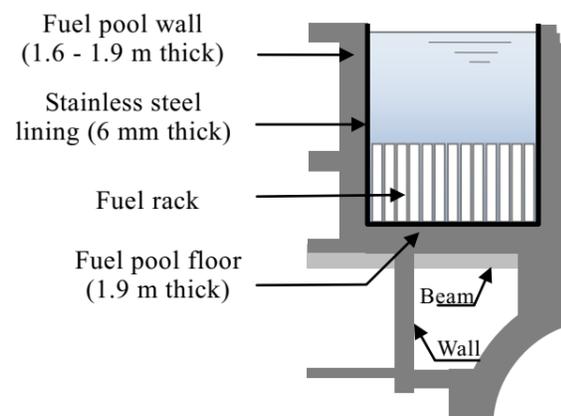
Fig. 3: Diagram of fuel pool

- The fuel pool is made of reinforced concrete 1.6 - 1.9 m thick. The interior is lined with stainless steel to prevent leakage (Fig. 3). Because stainless steel is more ductile than reinforced concrete, the lining remains sound even if tiny cracks, etc. develop in the walls or floor of the reinforced concrete. Moreover, there are no pipes, etc. going through the sides or floor of the pool that would give pool water a place to leak out.
- Even if the functions for cooling fuel pool water and injecting more water were lost, there is a margin of 100 days or more until fuel is left exposed by evaporation, etc. In the meantime, it would be possible to inject water into the fuel pool using portable power pumps that have been deployed as an urgent safety measure.

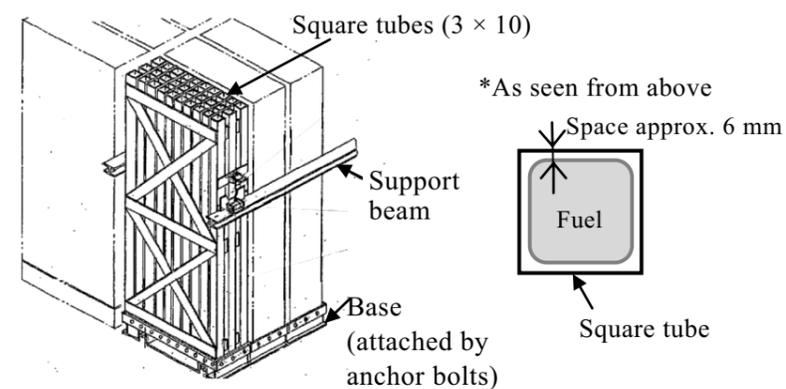
Fig. 4: Diagram of fuel rack

- We confirmed that fuel sub-criticality would still be ensured even if the supporting function (support beams and anchor bolts) of the fuel racks (Fig. 4) were lost and the fuel racks came into direct contact with adjacent fuel racks (with no clearance between them).
- We confirmed that the square tubes of the fuel racks would deform by a maximum of approximately 1 mm even if the value occurring in elastic analysis reached design tensile strength  $S_u$ . This is sufficiently smaller than the space between the square tubes and fuel (approximately 6 mm), so there would be no impact on fuel soundness.
