Inspection Results for Low-Pressure Turbine Moving Vane Mounting Assemblies (on the Shaft Side) in Hamaoka Unit 3 and Unit 4 with Causes and Countermeasures

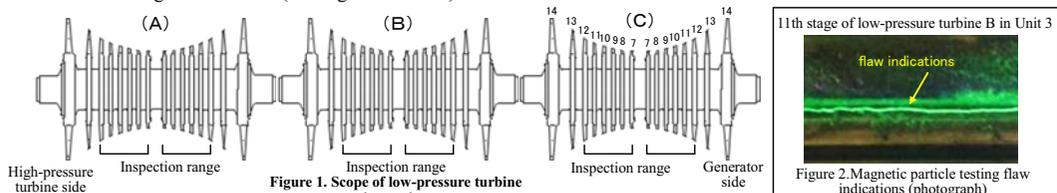
■ Magnetic particle testing was conducted on moving vane mounting assemblies in the 7th to 12th stages, which are of the same construction as the areas in which cracking and fractures were found in other nuclear power stations. This testing found that cracking had occurred. (See Figures 1 and 2.)

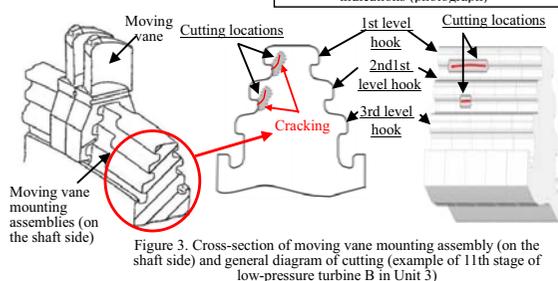
■ In order to survey the depth of cracks in the areas where their presence was confirmed by magnetic particle inspection, the areas were machined until the cracks were eliminated, and these areas were then subjected to a strength evaluation. The results showed that there were certain areas where it would be difficult to restore the moving vanes. (See Figure 3.)

■ Samples (cracked areas) were taken from the moving vane mounting assemblies (shaft side) where the presence of cracks had been verified, and these samples were subjected to surface examination using microscopes. It was determined that the cracks occurred along the grain boundaries of the metal microstructures. (See Figure 4.)

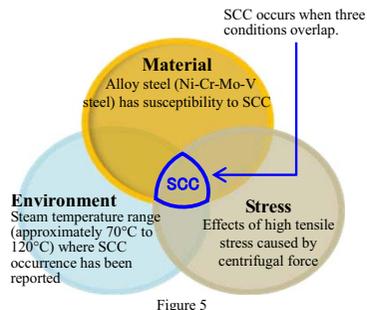
The results of surface examination by microscope indicate that the cracking in moving vane mounting assemblies (on the shaft side) occurred along grain boundaries in the metallographic structure. Where the cracking advanced internally, it was found to split into multiple branches. Given these examination results, the material of the moving vane mounting assemblies in the low-pressure turbines, the operating environment, and the circumstances of the stress generated, the cracking that occurred is inferred to have been stress corrosion cracking (SCC). (See Figures 4 and 5.)
